Manhole Inspection Summary

Manhole # **S15C__018MH**

Insp Date: **11/29/07 11:40 AM**

Location Address: **SIDE 600 WHITMORE**

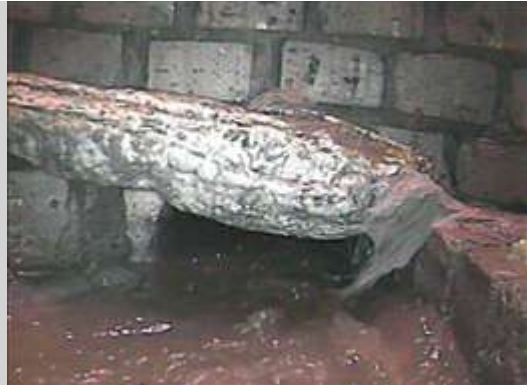
12 O'Clock Outflow

8 in. Circular Gravity Sewer
Pipe Out @ 12 O'Clock

Pipe Height: (in.) Direct
Pipe Material: **Clay** ☐ Pipe Lined
Invert Depth: **8.78** (ft.) Flow Characteristics: **Slow**
Deposits: ☒ None ☐ Mud ☐ Sludge ☐ Debris ☐ Grease
Silt Depth: (in.) Deposits Extent:
Infiltration: **None** Pipe Seal Cond: **Unknown**

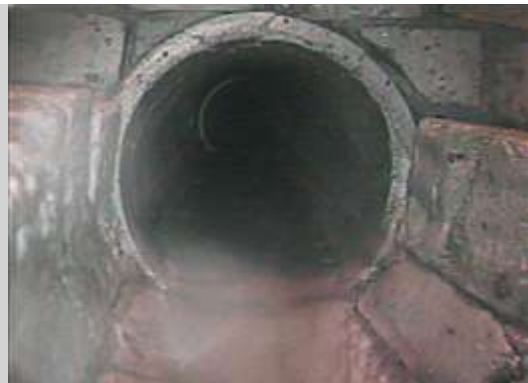
9 O'Clock Inflow

8 in. Circular Gravity Sewer

Pipe In @ 9 O'Clock

Infiltration: **None** Pipe Seal Cond: **Sound**
